SUBJ: Resource Conservation Recovery Act (RCRA) Compliance Evaluation Inspection
(CEI) Clorox Products Manufacturing Company (GAD 051 039 402)

**United States Environmental Protection Agency (EPA)
Region 4, Atlanta, Georgia
Compliance Evaluation and Inspection Report**

Clorox Products Manufacturing Company
17 Mirror Lake Road
Forest Park, Georgia 30297

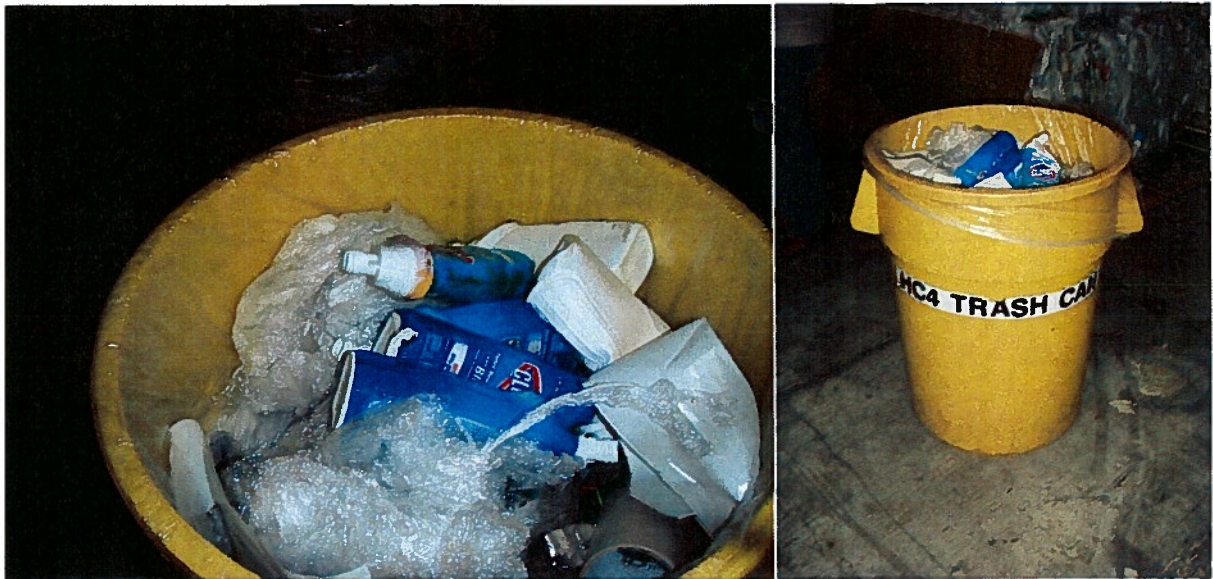
The Recycling Area was located in the rear of the conveyor belt production line. Bails of containers and bottles that have been discarded and rejected from the process were located in the Recycling Area. These bails are managed using a forklift. During management of the bails some of the bottles and containers may be freed of the bail and fall to the floor in the Recycling Area. These bottles are picked up and placed in the trashcan located in the Recycling Area as seen in Figures 5 and 6 of Attachment 1. These bottles are allowed to drain into the trashcan and then re-bailed for recycling. It is recommended that Clorox allow the bottles to drain before they are bailed initially to reduce the possibility of environmental releases, insure proper disposal and reduce risk to human health.

Figure 5 & 6: Trashcan located in the Recycling Area. Trashcan contains bottles that have fallen out of bails that are to be sent to the Recycler. These bottles are being allowed to drain before re-bailing for shipment to Recycler.

1. Allow the bottles to drain before they are bailed initially to reduce the possibility of environmental releases, insure proper disposal and reduce risk to human health.
2. Add the contact numbers for the National Response Center, the local Fire Department, and Georgia Environmental Protection Division.
3. It is recommended that an acceptable area be set aside to store solid waste and that solid waste not be stored in the isle way of the Ink Satellite Accumulation Area.
4. In order to comply strictly with the regulations, it is suggested that the management of this satellite accumulation area be reevaluated.

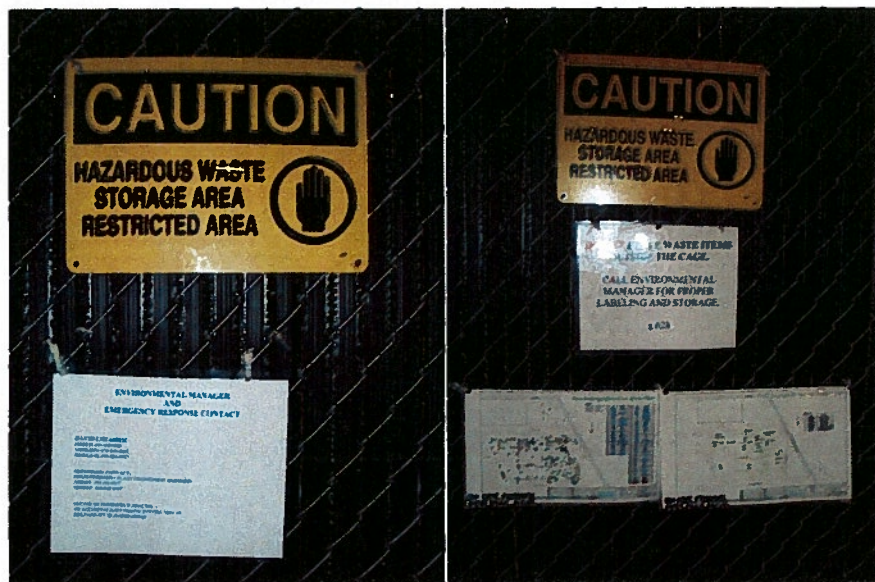
The Less Than 180-Day Hazardous Waste Storage Area (Storage Area) was located in the rear of the conveyor belt production line next to the Recycling Area. The Storage Area was locked and enclosed in chain link fence with signage designating the area, as seen in Figures 8 and 9 of Attachment 1. In addition to signage indicating that this area held hazardous waste, the gate to the Storage Area bore a fire extinguisher location map, spill kit location map and contact numbers for Mr. Creamer, Environmental Manager, and Mr. Pinkston, Plant Engineering Manager. A photo of the call down list posted on the gate of the Storage Area can be seen in Figure 32 of Attachment 1. It is recommended that contact numbers for the National Response Center, the local Fire Department, and Georgia Environmental Protection Division be added to this list.

Figure 7 & 8: Hazardous placard, emergency contacts, and evacuation plan posted on the gate leading to the Less Than 90 Day Storage Area.

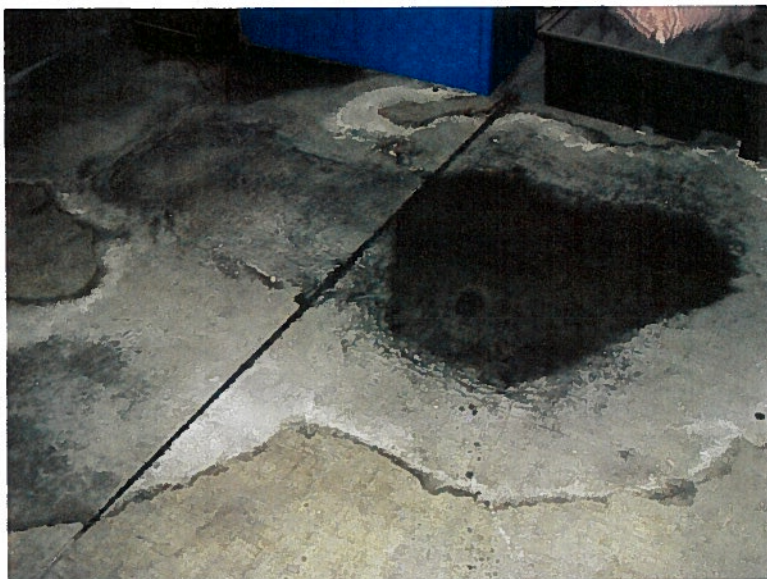
At the time of the CEI, the Storage Area held no hazardous waste. In the rear of the Storage Area, several containment pallets were indicated as the location where hazardous waste would be stored. The floor in the Storage Area was wet. The floor had been allowed to dry and a white residue had formed, as seen in Figure 9 and 11 of Attachment 1. Mr. Creamer indicated that some water had been spilled outside the area and flowed into the Storage Area from under the fencing. The inspectors recommended to Mr. Creamer that the floor should be cleaned promptly after all spills. The Storage Area held boxes, plastic for recycling, empty drums and trashcans as seen in Figure 11 of Attachment 1.

Figure 9: Floor in the Less Than 90 Day Storage Area.

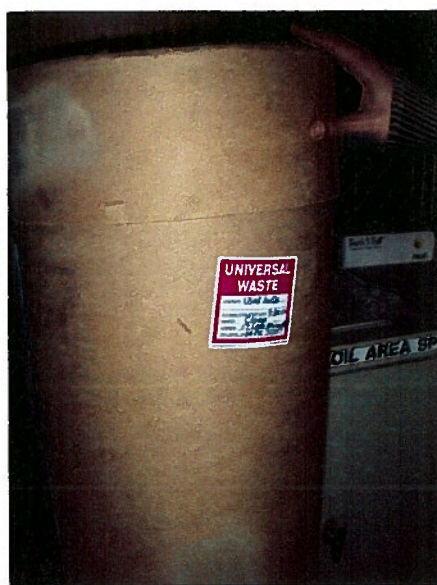
Universal Waste Storage was located inside the Storage Area and limited to a separate section with a shelf. A box of spent lamps was located in the Universal Storage Area. This box was found to be closed, labeled and dated as seen in Figure 10 of Attachment 1.

Figure 10: Box of spent lamps labeled Universal Waste and found in a closed and dated cardboard container.

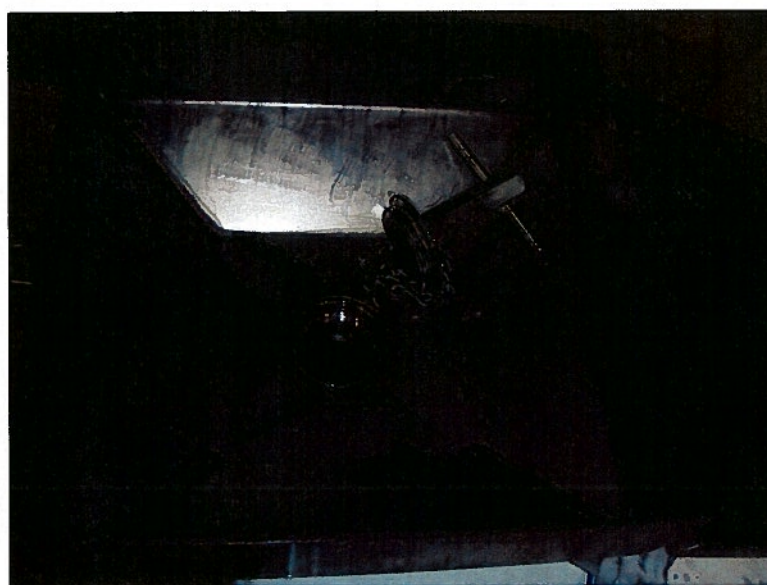
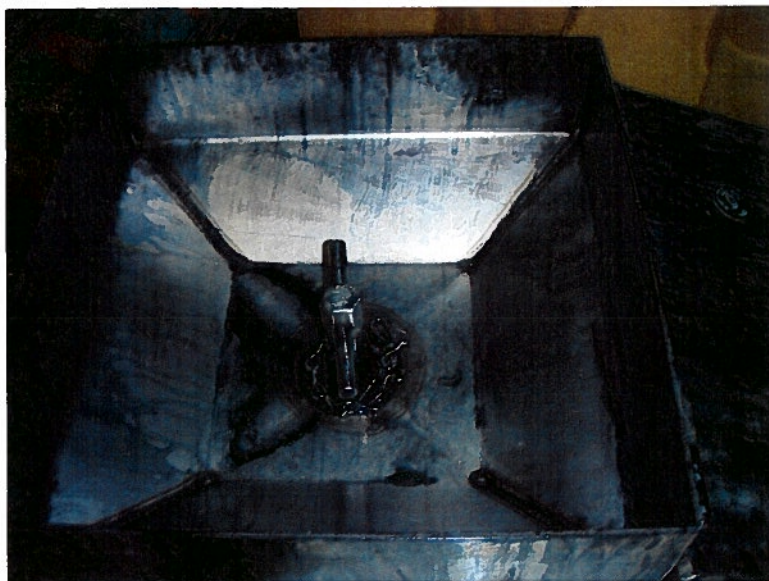
The blue metal drum had a metal funnel cap with a screw in plug which sealed the container properly to prevent a spill in the event that the container was tipped as seen in Figures 12 and 13 of Attachment 1. The blue metal drum contained waste ink as indicated by a paper label bearing the words "Ink Satellite Waste Container." The inspectors indicated to Mr. Creamer that the container should bear the words "Hazardous Waste" in order to distinguish this waste from solid waste.

Figure 12: The funnel that capped the Waste Ink Drum Satellite Drum. This funnel was found sealed and closed.

Figure 13: Funnel Cap located atop the Waste Ink Satellite Drum.

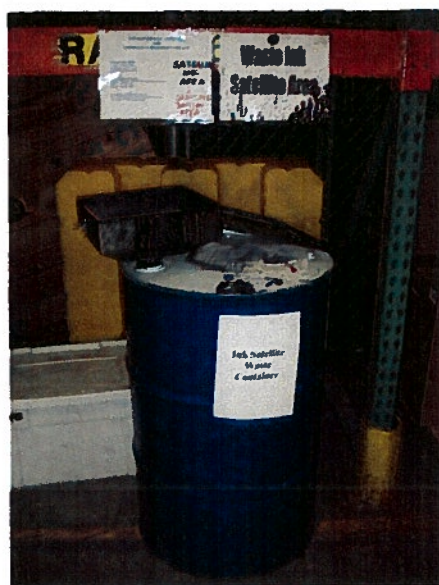
The Ink Satellite Accumulation Area, located immediately next to the Storage Area, can be seen in Figure 14 of Attachment 1. The Ink Satellite Accumulation Area was indicated by a sign on the shelf above it and was accompanied by a call down list. One 55-gallon blue metal drum and a Rubbermaid® tote were located in the Ink Satellite Accumulation Area at the time of the CEI.

Clorox was in apparent violation of Chapter 391-3-11-.08 of the Georgia Hazardous Waste Management Act which incorporates by reference 40 C.F.R.

§ 262.34(c)(1)(ii). A generator must mark containers either with the words "Hazardous Waste" or with other words that identify the contents of the containers.

Figure 14: Waste Ink Satellite Drum labeled Ink Satellite Waste Container. The words Hazardous Waste are not found on the label.

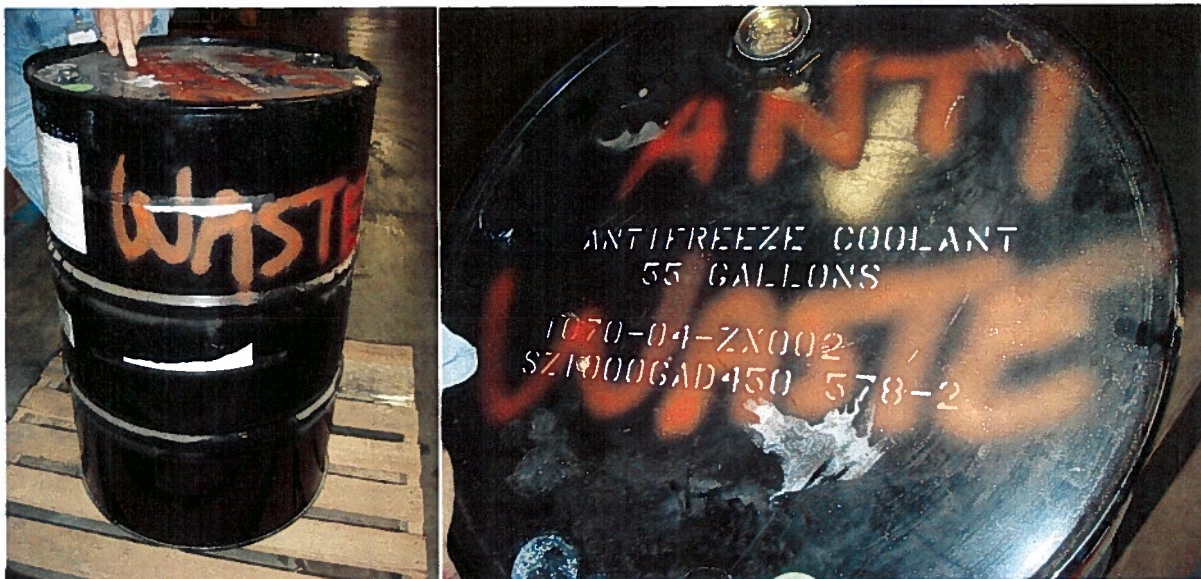
In the isle way by the Ink Satellite Accumulation Area a black 55-gallon drum labeled "Waste Anti" was located as seen in Figures 15 and 16 of Attachment 1. It is recommended that an acceptable area be set aside to store solid waste and that solid waste not be stored in the isle way of the Ink Satellite Accumulation Area.

Figure 15 & 16: 55 gallon drum located in the Waste Ink Satellite Area labeled waste antifreeze.

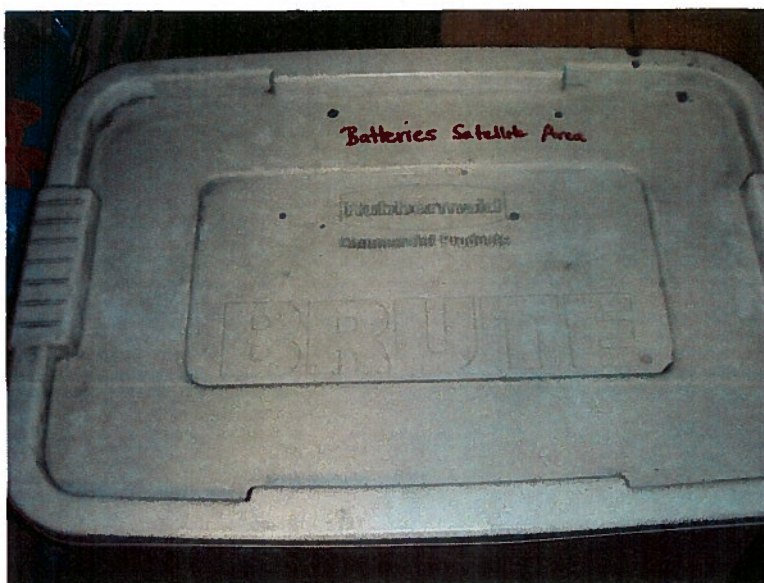
Figure 17: Rubbermaid tote used to store miscellaneous batteries for disposal.

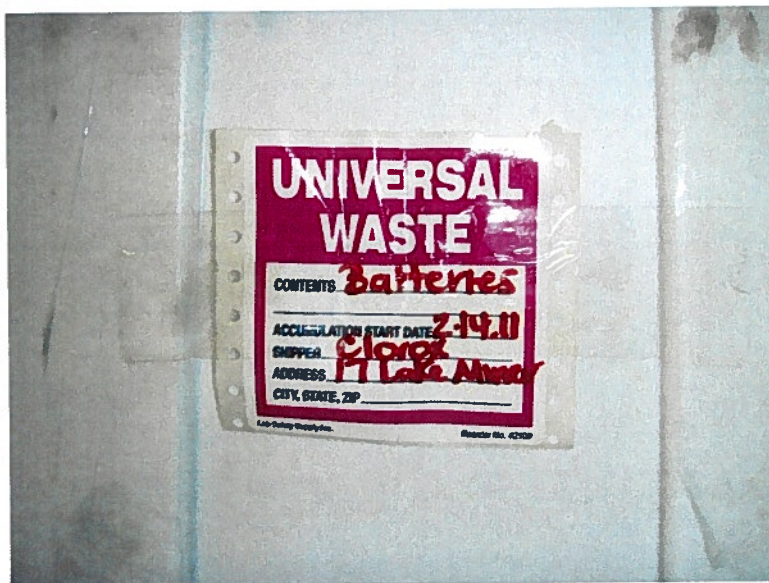
The Rubbermaid® tote contained spent batteries in a variety of sizes. This was indicated by a Universal Waste label dated February 14, 2011, and affixed to the front of the tote as seen in Figure 18 of Attachment 1.

Figure 18: Label located on the side of the Rubbermaid tote containing miscellaneous spent batteries.

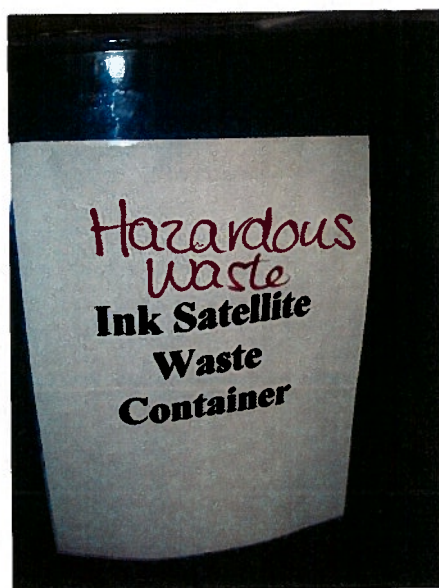
Figure 19: Correction made to the Ink Satellite Waste drum while EPA Inspectors were present.

Mr. Creamer immediately wrote the words "Hazardous Waste" on the container label as seen in Figure 19 of Attachment 1. Mr. Creamer informed the inspectors that the drum would bear the words "Hazardous Waste" from that time forward.

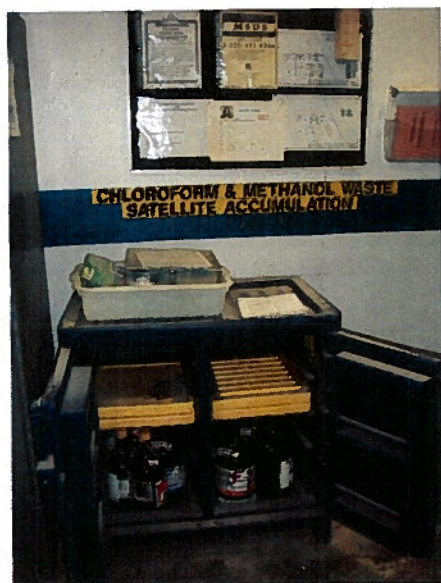
The Laboratory Satellite Accumulation Area located outside the door to the Laboratory and was indicated by a label on the wall as seen in Figure 20 of Attachment 1. The cabinet located in this area contained 7 bottles of hazardous waste.

The Laboratory Satellite Accumulation Area is intended to be used as a satellite accumulation area. However, since the area contained 7 full bottles of hazardous waste, 6 of which were dated, it is the opinion of EPA that this area is being used as a hazardous waste storage area. In order to comply strictly with the regulations, it is suggested that the management of this satellite accumulation area be reevaluated.

Figure 20: Cabinet outside of the Lab Area. This cabinet was found to house 7 bottles of waste.

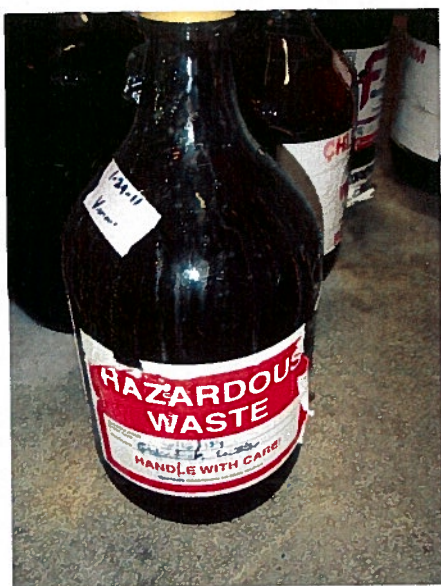
The first bottle that was inspected was a 2.5 liter bottle that was labeled with the words "Hazardous Waste" as seen in Figure 21 of Attachment 1. This bottle was found to bear two separate dates January 29, 2011 and May 16, 2009.

Clorox was in apparent violation of Chapter 391-3-11-.08 of the Georgia Hazardous Waste Management Act which incorporates by reference 40 C.F.R. § 262.34(a)(2). The date upon which each period of accumulation begins is clearly marked and visible for inspection on each container.

Figure 21: 2.5 liter bottle of Waste Chloroform located in the cabinet outside of the lab. Bottle labeled with 2 dates, 1-29-11 and 5-16-09.

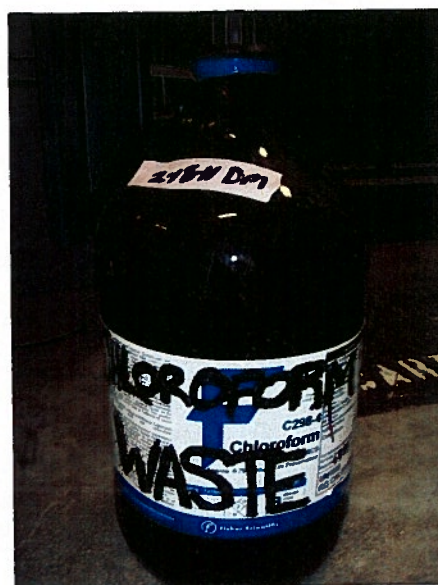
The second bottle inspected was a 4-liter bottle that was labeled with the words "Chloroform Waste" as seen in Figure 22 of Attachment 1. This bottle was dated February 18, 2011.

Figure 22: 4 liter bottle of Waste Chloroform dated 2-18-11 but without a Hazardous Waste label located in the cabinet outside of the lab.

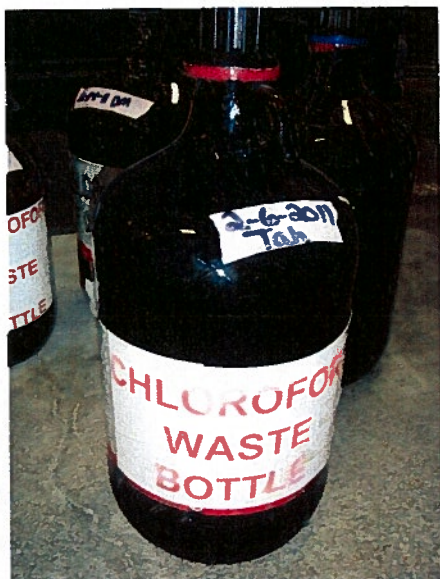
The third bottle inspected was a 4-liter bottle that was labeled with the words "Chloroform Waste Bottle" as seen in Figure 23 of Attachment 1. This bottle was dated February 6, 2011.

Figure 23: 4 liter Waste Chloroform bottle dated 2-6-2011 without Hazardous Waste label located outside of the lab.

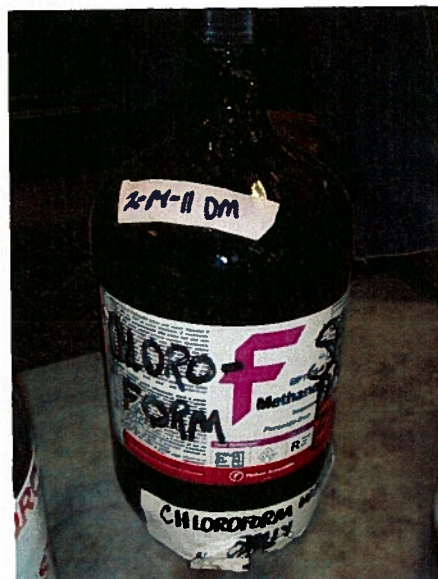
The fourth bottle inspected was a 4-liter bottle labeled with the words "Chloroform Waste Only" as seen in Figure 24 of Attachment 1. This bottle was dated February 14, 2011.

Figure 24: 4 liter bottle of Waste Chloroform dated 2-14-11 with no Hazardous Waste label.

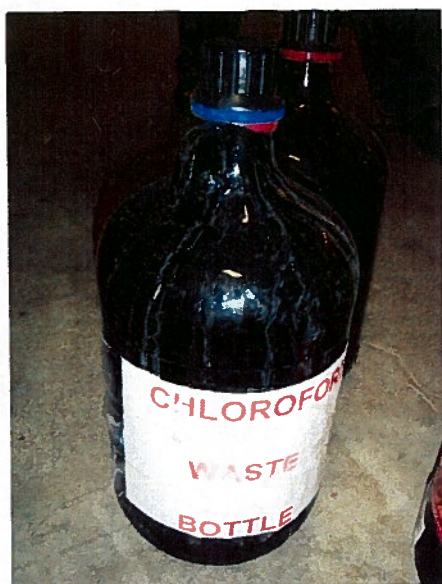
The fifth bottle inspected was a 4-liter bottle labeled with the words "Chloroform Waste Bottle" as seen in Figure 25 of Attachment 1. This bottle was undated.

Clorox is in apparent violation of Chapter 391-3-11-.08 of the Georgia Hazardous Waste Management Act which incorporates by reference 40 C.F.R. § 262.34(a)(2). The date upon which each period of accumulation begins is clearly marked and visible for inspection on each container.

Figure 25: Waste Chloroform bottle located outside of the lab with no date and no Hazardous Waste label.

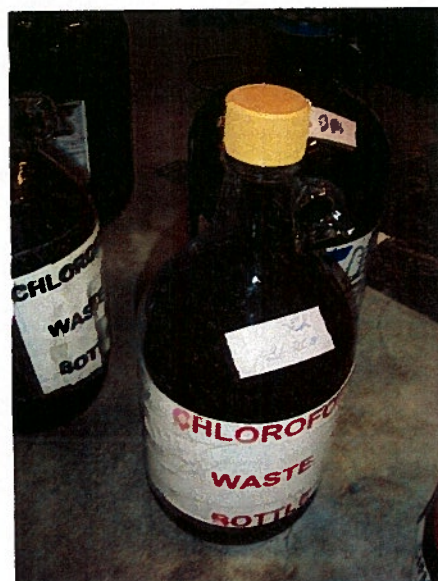
The sixth bottle inspected was labeled with the words "Chloroform Waste Bottle" as seen in Figure 26 of Attachment 1. This bottle was dated January 31, 2011.

Figure 26: Waste Chloroform bottle located in cabinet outside of the lab dated 1-31-11 with no Hazardous Waste label.

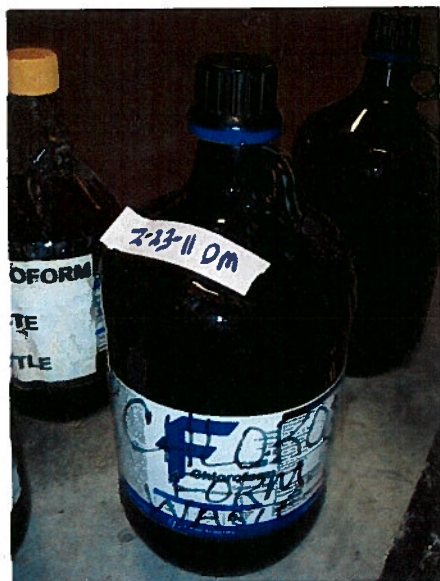
The seventh bottle inspected was labeled with the words "Chloroform Waste" as seen in Figure 27 of Attachment 1. This bottle was dated February 23, 2011.

Figure 27: Waste Chloroform bottle located in cabinet outside of lab dated 2-23-11 with no Hazardous Waste label.

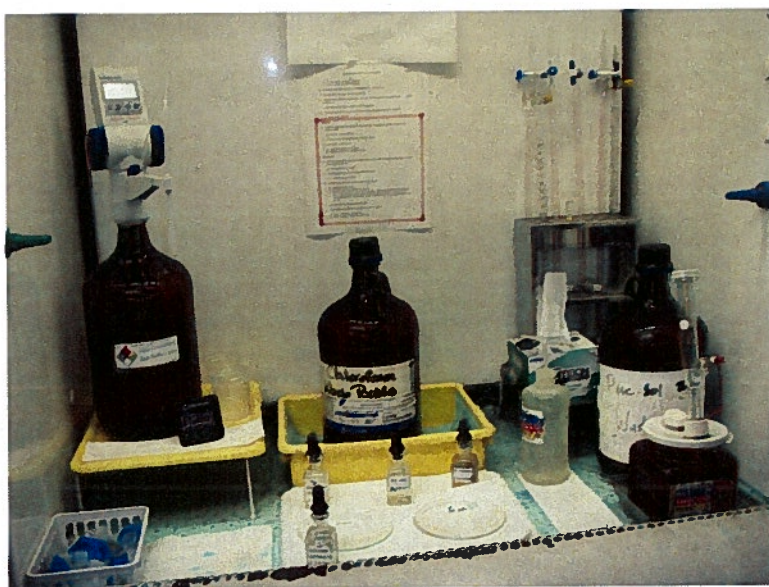
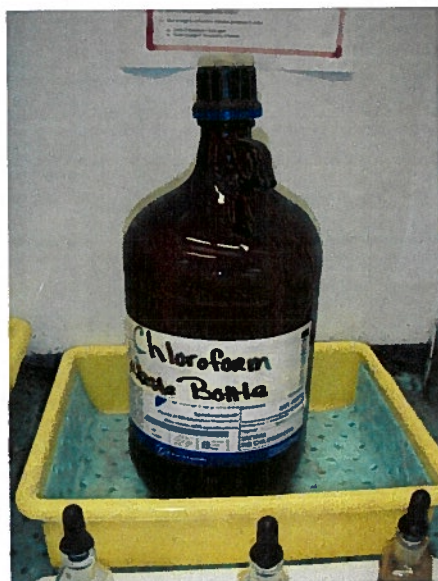
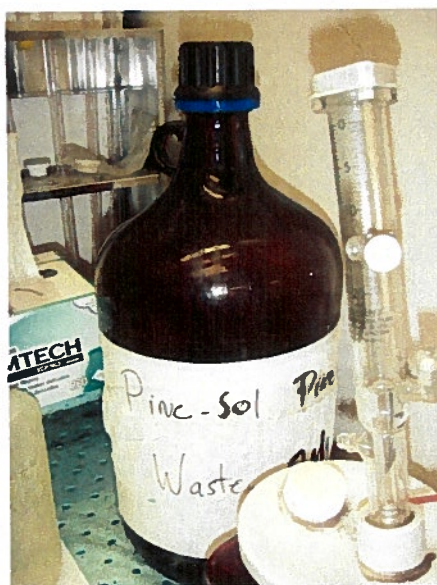
The laboratory contained a fume hood which housed a 4-liter "Chloroform Waste Bottle" and a "Pine-sol Waste Bottle" as seen in Figures 28-30 of Attachment 1. These bottles were located at the point of generation, closed and labeled with the contents. Mr. Creamer indicated that the Pine-sol Waste would be recycled into the process. The trashcan in the Laboratory was found to contain personal protective equipment (PPE) and pipettes as seen in Figure 31 of Attachment 1. The inspectors asked if Clorox had ever profiled the waste coming from the lab operations that was being disposed of in the trashcan. Mr. Creamer indicated that the waste had not been profiled.

Figure 28: Contents of fume hood in lab.

Figure 29: Waste Chloroform bottle located in the fume hood in the lab with no Hazardous Waste Label.

Figure 30: Pine-sol Waste bottle located in the fume hood in the lab.

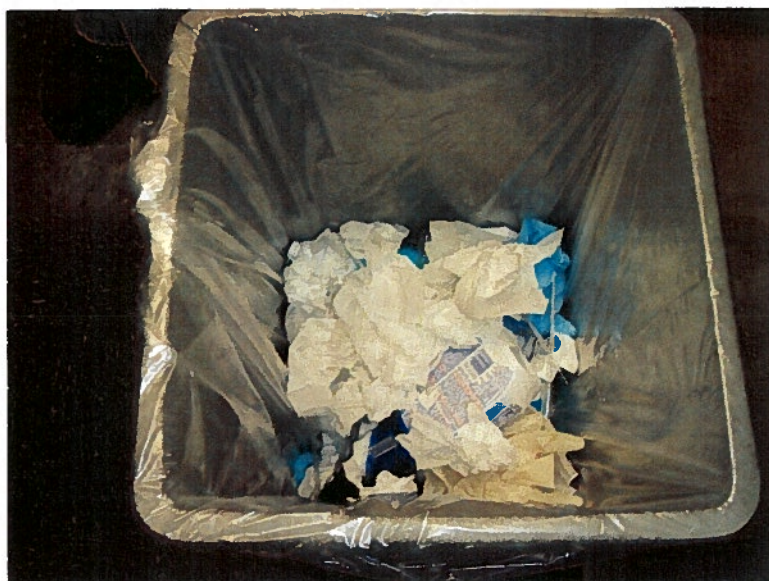
Clorox was in apparent violation of Chapter 391-3-11-.08 of the Georgia Hazardous Waste Management Act which incorporates by reference 40 C.F.R. § 262.11, for failing to make a hazardous waste determination.

Figure 31: Contents of trashcan in the lab includes PPE and pipettes.
